Manhole Inspection Summary

Manhole # S17I__024MH

Insp Date: **8/3/09 8:53 AM**

Location Address: **2301 CALVERTON ROAD**

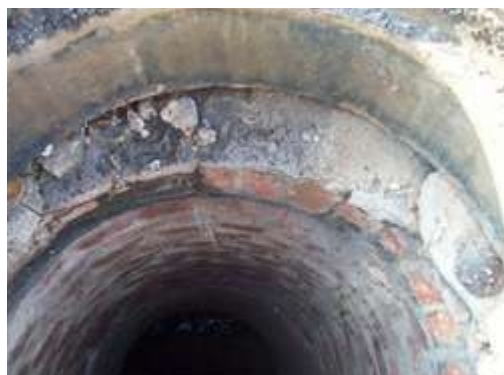
Defect 2

Offset: **2** (in.)

Condition: ☐ Sound ☐ Cracked ☐ Root Intrusion ☐ Loose Brick ☒ **Deteriorated**

OFFSET FRAME AND DETERIORATED CHIMNEY

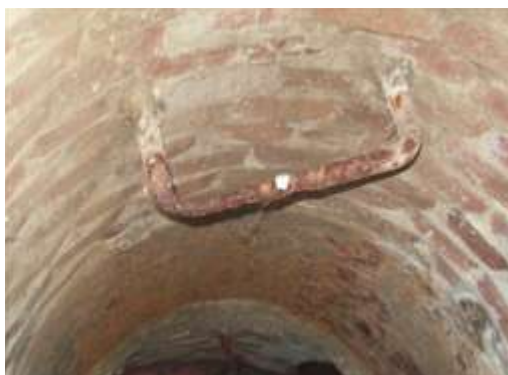
Defect 1

Count: **10** Missing: **0** ☒ **Corroded**

CORRODED STEPS

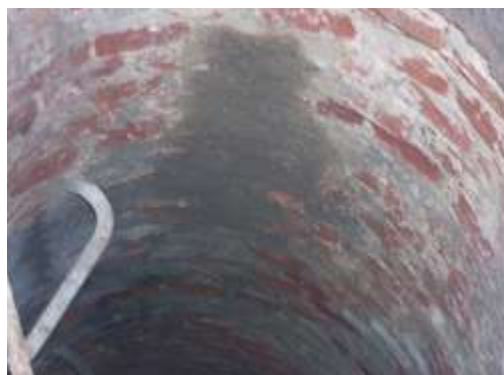
Defect 4

Infiltration: ☐ None ☐ Joint ☐ Cracks ☐ Mortar ☐ Roots ☒ **Wall**

INFILTRATION AT CORBEL

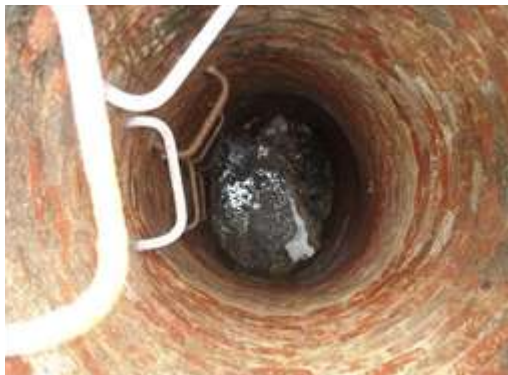
Defect 3

☒ **Evidence Of Surcharge** Depth: **1** (ft.) ☒ **Active Surcharge Present**

evidence of ASUR

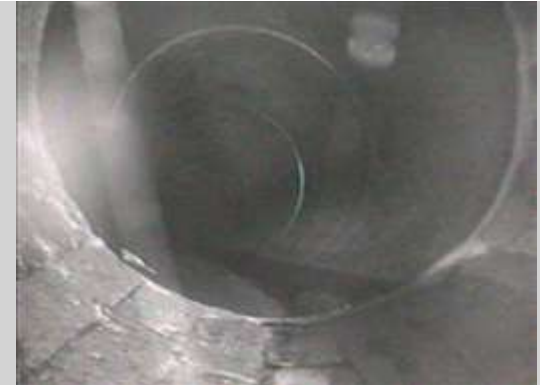
12 O'Clock Outflow

Pipe Height: **8.4** (in.) Rod and Bar (Angled)
Pipe Material: **Clay** ☐ Pipe Lined
Invert Depth: **14.70** (ft.) Flow Characteristics: **Slow**
Deposits: ☐ None ☐ Mud ☐ Sludge ☒ **Debris** ☐ Grease
Silt Depth: **4** (in.) Deposits Extent: **Medium**
Infiltration: **None** Pipe Seal Cond: **Sound**

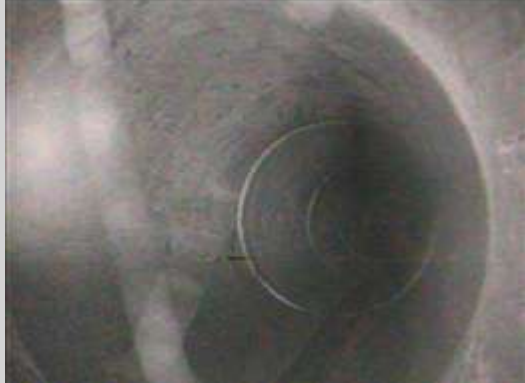
6 O'Clock Inflow

Deposits: ☐ None ☐ Mud ☐ Sludge ☒ **Debris** ☐ Grease

Silt Depth: **5** (in.) Deposits Extent: **Heavy**
